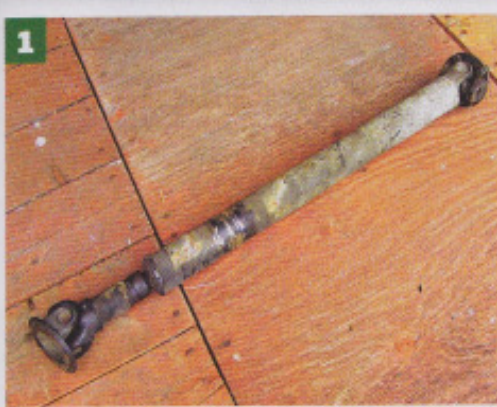
1 Remove the propshaft. This is the general state of most hard-worked driveshafts. An opposite twist of the flanges often reveals a little play in the universal joint's bearings.

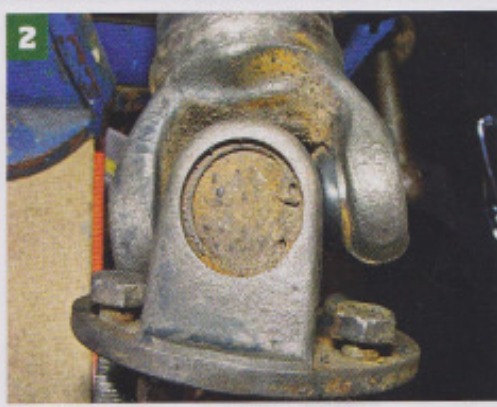
2 Each bearing cup is retained by an internal circlip. These may be rather dirty or rusted, so give them a soak in some release fluid before attempting to remove them.

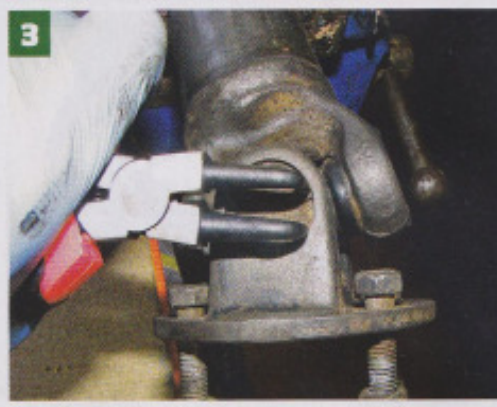
3 Give the propshaft yokes a clean and then, concentrating on one joint at a time, extract the circlips using circlip pliers. If a clip is tight, tap the bearing cup inwards a tad to reduce pressure.

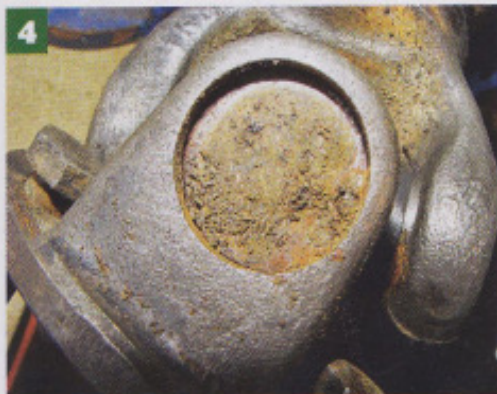
4 The joint should now look like this. Next, find two sockets or similar tubular items, one of a slightly lesser diameter than the cup and another greater.

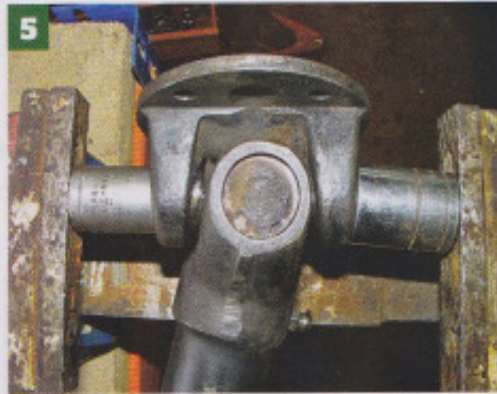
5 Place the universal joint and sockets in the jaws of a vice. The larger socket must be positioned with its driving end over one yoke, with the smaller bearing against the opposite cup.

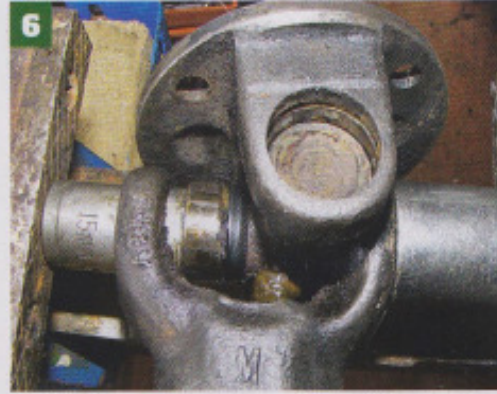
6 The bearing cups and the central spider should be pressed through the yoke until the outermost cup drops free. In some cases you may need to ease this out with a pair of grips.

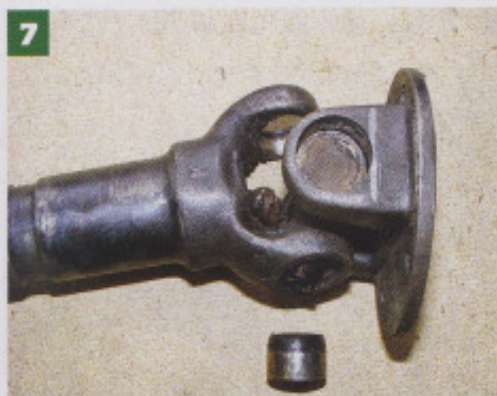
7 The spider can now be tilted and the opposite cup removed. This then allows the two yokes to be separated. Repeat the process to remove the joint completely.

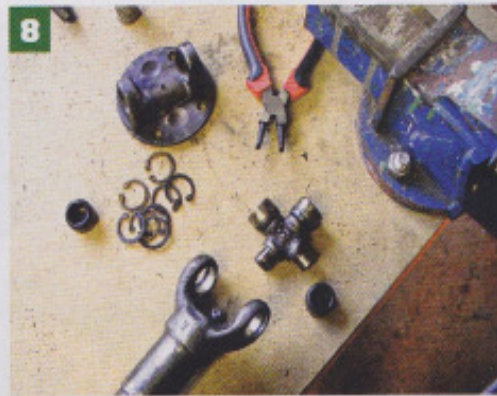
8 The result should be a bunch of components looking something like the above. Repeat the process for the opposite end of the propshaft and clean up the remaining areas ready for paint.

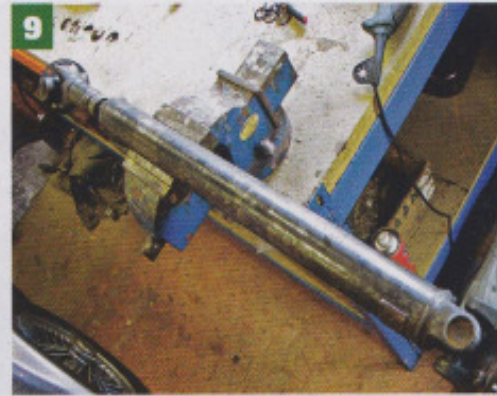
9 There are a few more checks to make before painting and build proceed. Ensure that the joints are aligned. Here, the couplings are misaligned. This will lead to unwanted vibration.

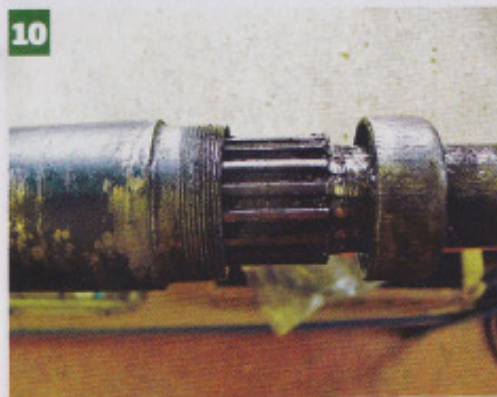
10 Propshafts often feature a sliding joint, to allow for length variation due to the deflection of the suspension. Unscrew the cap and inspect the splines for wear, before cleaning thoroughly.

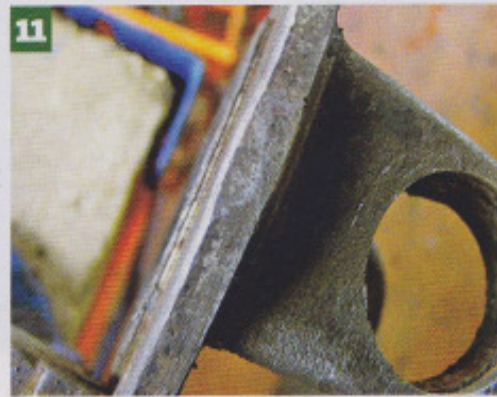
11 Inspect the end flanges for damage caused by heavy-handed removal techniques. This flange required a small amount of dressing with a file.

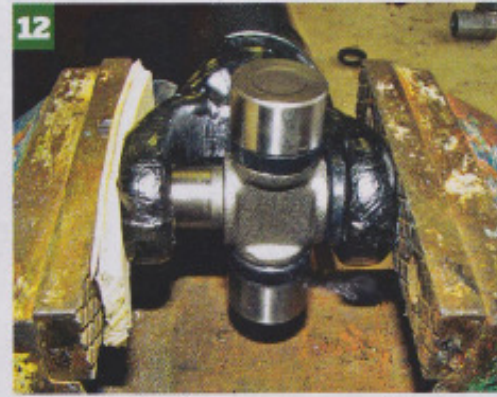
12 To reassemble, first press a new cup into the yoke using the vice. Once started, insert the spider. This cannot be achieved if the cup is in all the way.

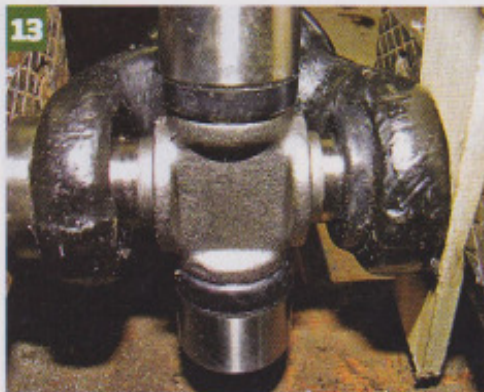
Repeat the process for the opposite cup, ensuring that none of the needles drop out of place. Use a smear of grease to hold them and try to avoid sudden jerking movements.

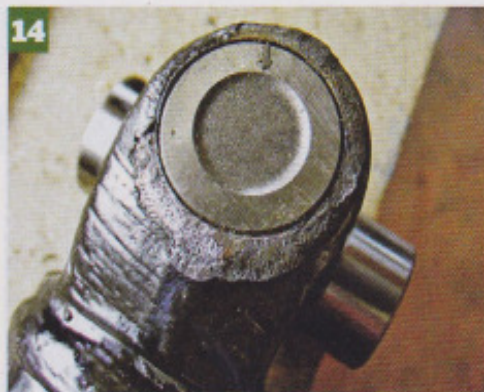
The last two steps will leave the cups outer faces flush with the surface of the yokes. To insert the circlips, they must be pressed further in using the socket method.

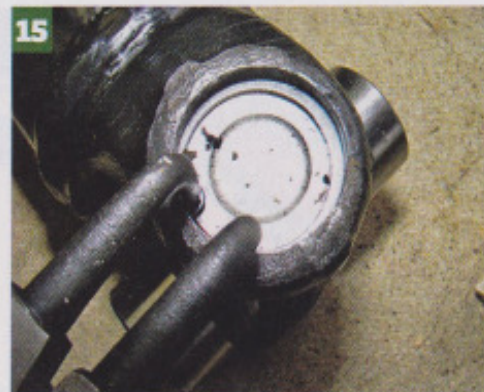
After pressing the cup in sufficiently, insert the clip into the groove using the circlip pliers. Be careful not to press the cup in too far, though.

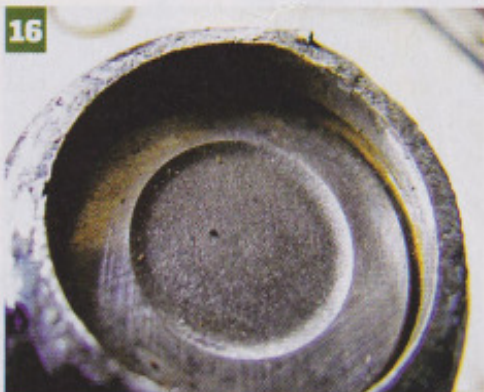
Here, the opposite cup has been pushed too far in and the clip groove is not fully revealed. This cup will need to be pressed in further, thus pushing its opposite number back.

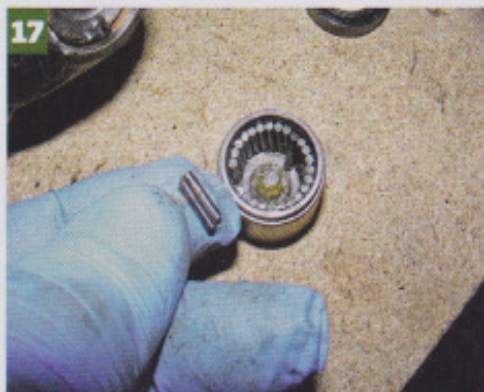
If a bearing cup refuses to press completely home, it may be that some of the bearing needles have dropped out of place. If this happens, you will have to repeat the whole dismantling process.

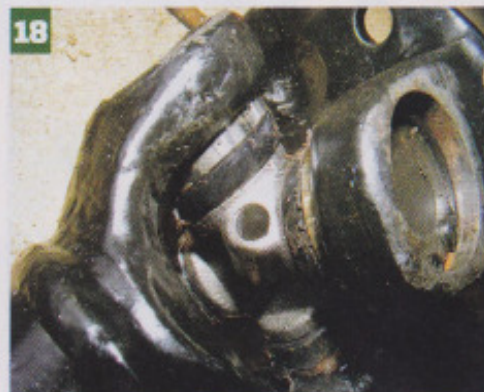
Once all of the cups have been pressed in and the circlips fitted, don't forget to fit the grease nipple. After that, grease the joint and clean away any excess.

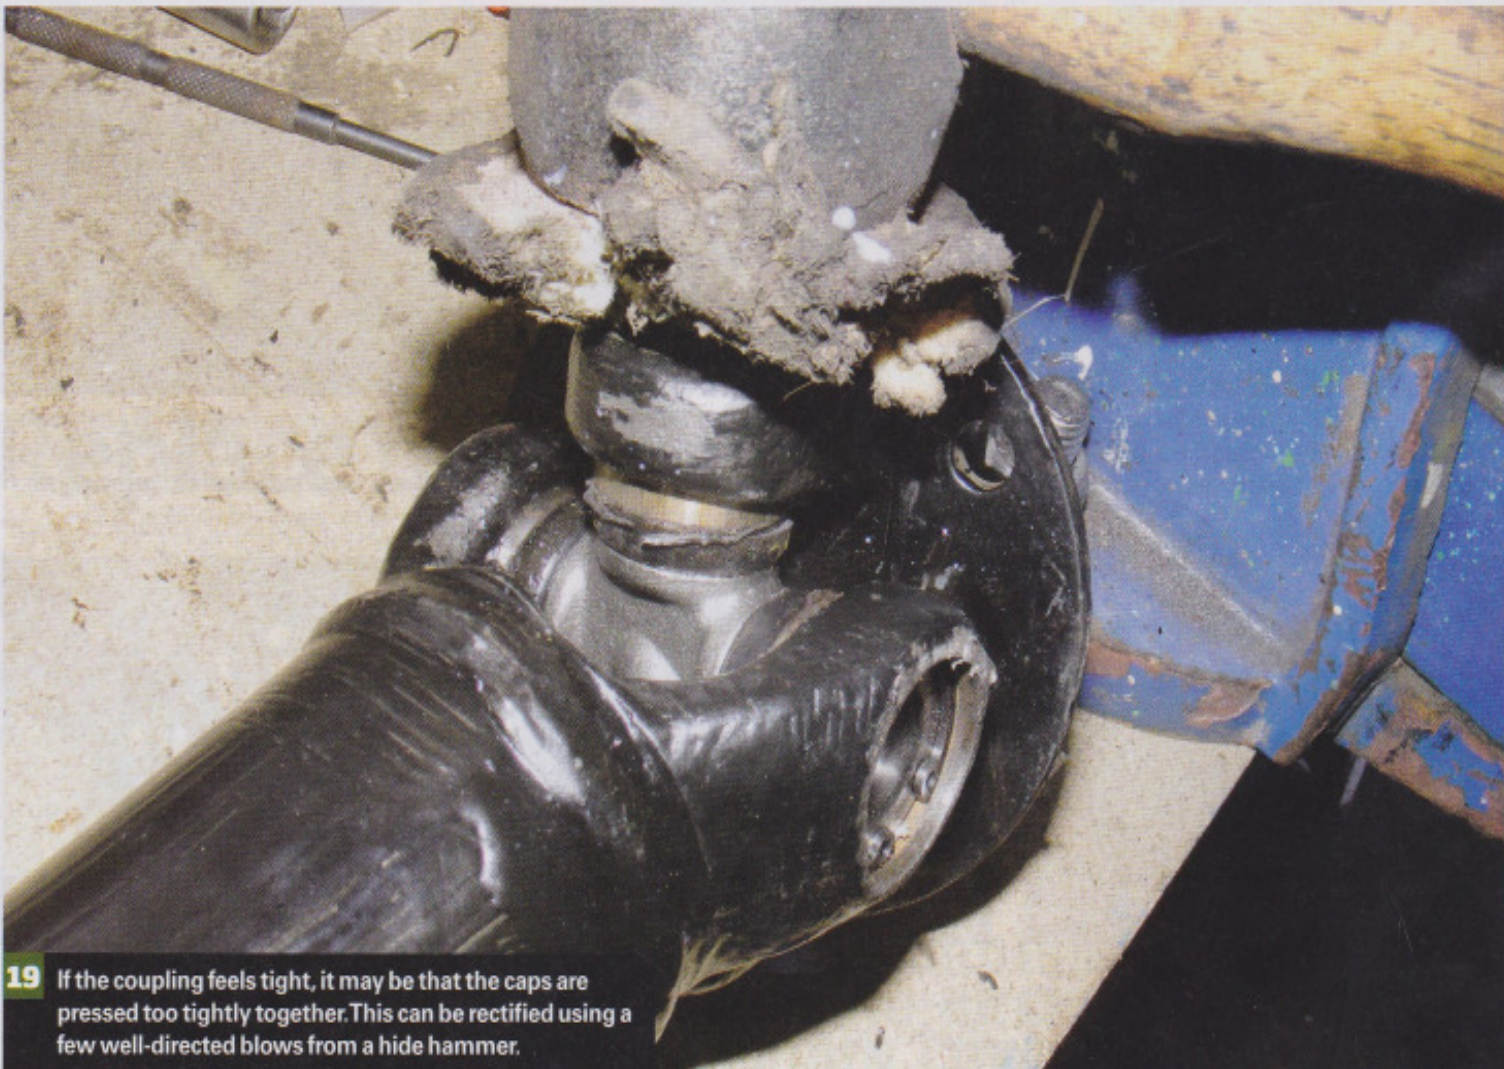
19 If the coupling feels tight, it may be that the caps are pressed too tightly together. This can be rectified using a few well-directed blows from a hide hammer.
